Figure Title:
Figure 16 - Geophysical Survey in Ammunition Breakdown Section (Zone K)

Project:
Bishopston Stage I Investigation

Report No: A385-00 Report No: A385-00-R4-1 Scale: 1:1,503

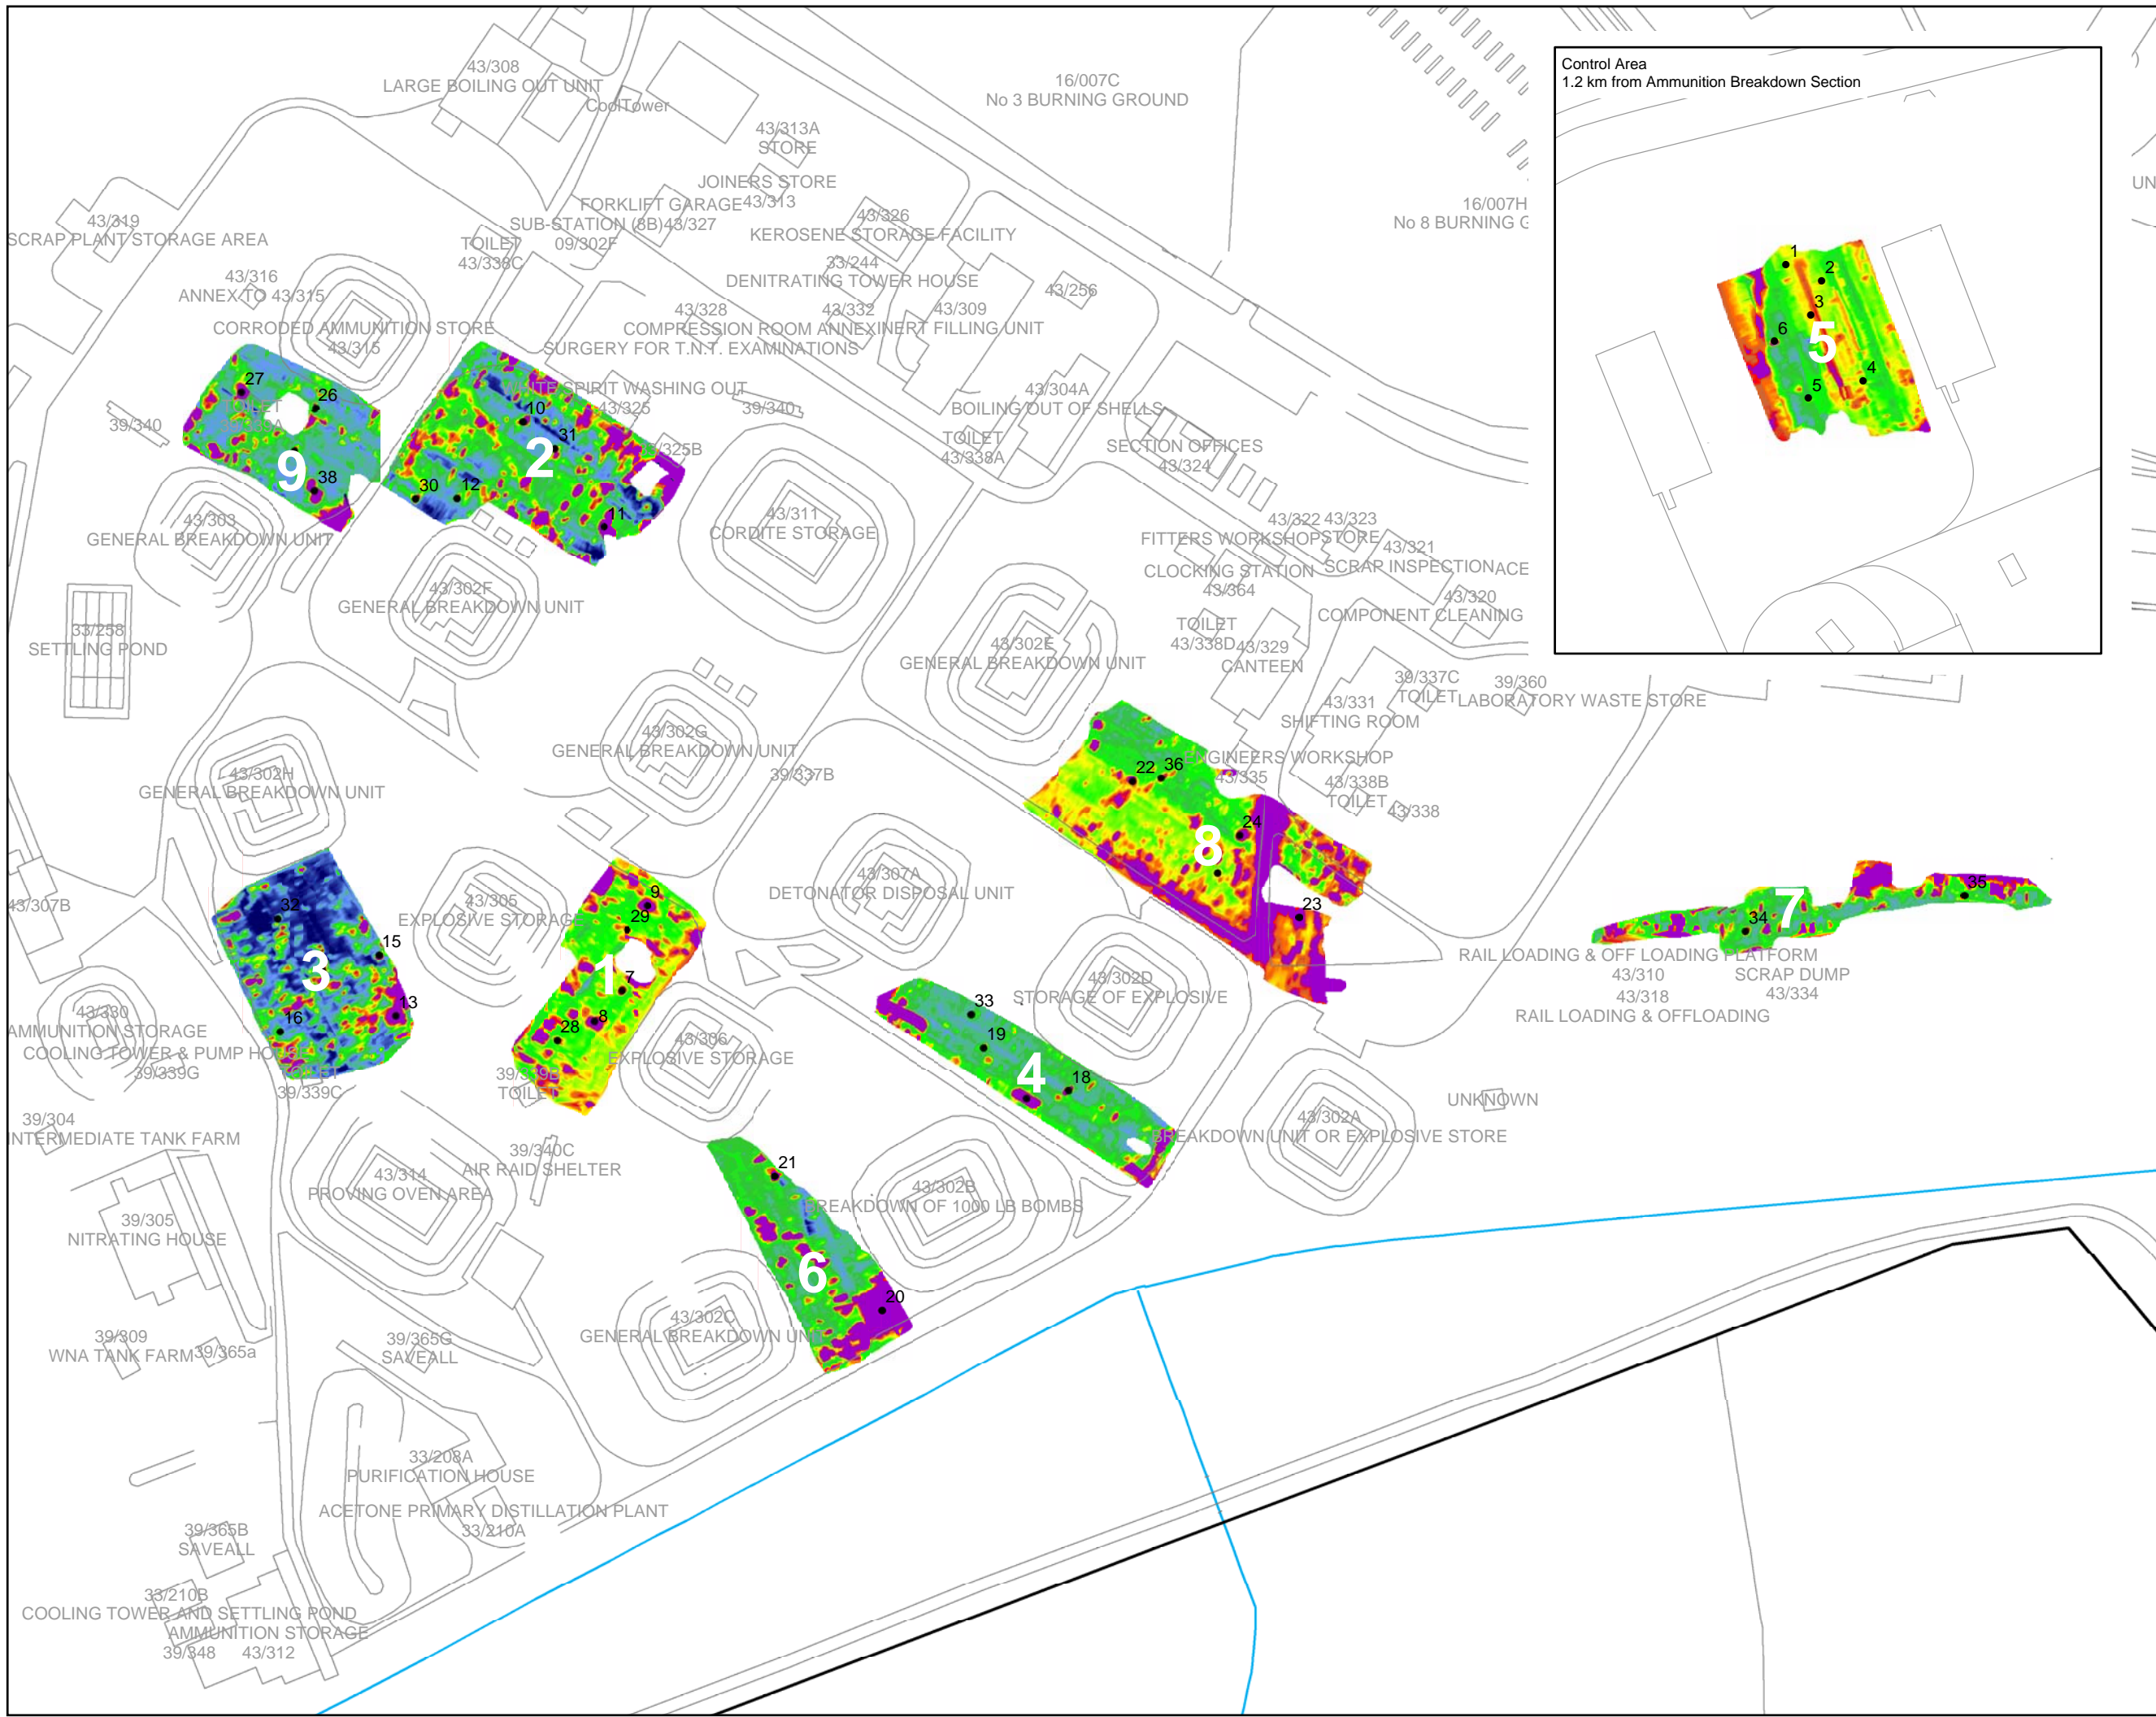
AnomalyNo	Description	Depth m
Control Area		
1	corroded smoke grenade	0.25
2	shell nose fuze	0.10
3	20 mm projectile	0.30
4	grenade stem assembly	0.20
5	30 mm case	0.15
6	105 mm shell	0.30
Ammunition Breakdown Section		
7	iron pipe	0.25
8	manhole	0.15
9	section of metal gutter	0.15
10	section of metal guttering	0.25
11	large section of sheet pile	0.20
12	small section of pipe	0.15
13	assorted metal fragments	0.10
14	iron pipe	0.15
15	section of corrugated iron	0.20
16	large nail/spike	0.10
17	large (5 m) section for iron/steel pipe	0.15
18	sheet metal	0.10
19	spade head	0.15
20	reinforced concrete	0.00
21	reinforced concrete posts	0.15
22	piece of metal	0.20
23	section of steel pipe and post	0.20
24	section of metal pipe	0.15
25	nails in wood and scattered in soil	0.15
26	reinforced HV tile	0.10
27	manhole	0.00
28	reinforced concrete posts	0.15
29	metal ring	0.15
30	reinforced concrete section and metal valve	0.15
31	section of pipe	0.10

32	piece of metal	0.00
33	section of metal pipe	0.10
34	metal wheel/disc	0.15
35	assorted waste and slag	0.10
36	small piece of metal	0.15
37	section of metal pipe	0.20
38	2 sections of ng track + section of metal pipe	0.10

Geophysical traces are for 'Coil 1'.
Differential conductivity readings were used for interpretation.
