Walkover Photographs (1)

Bishopton

A138-00-R1-1

BAE SYSTEMS

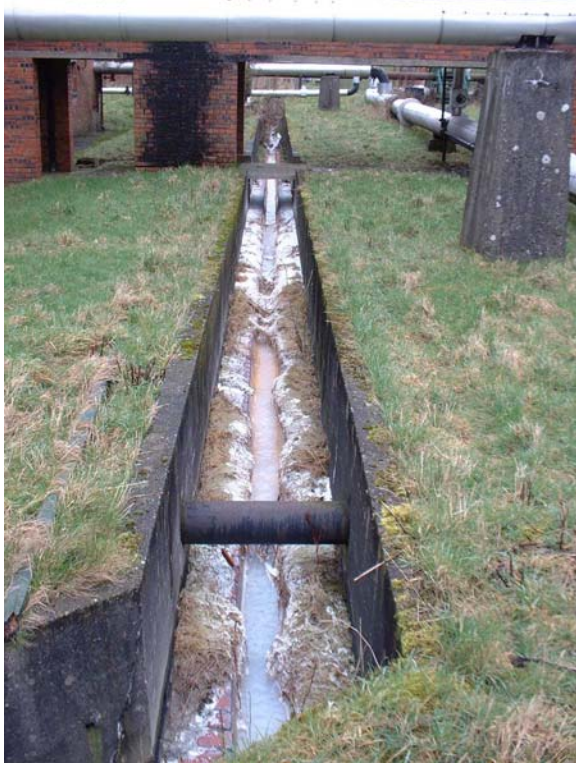
Plate 6.1 - Process drain from 25/105B (Factory I NC Section) showing NC accumulation

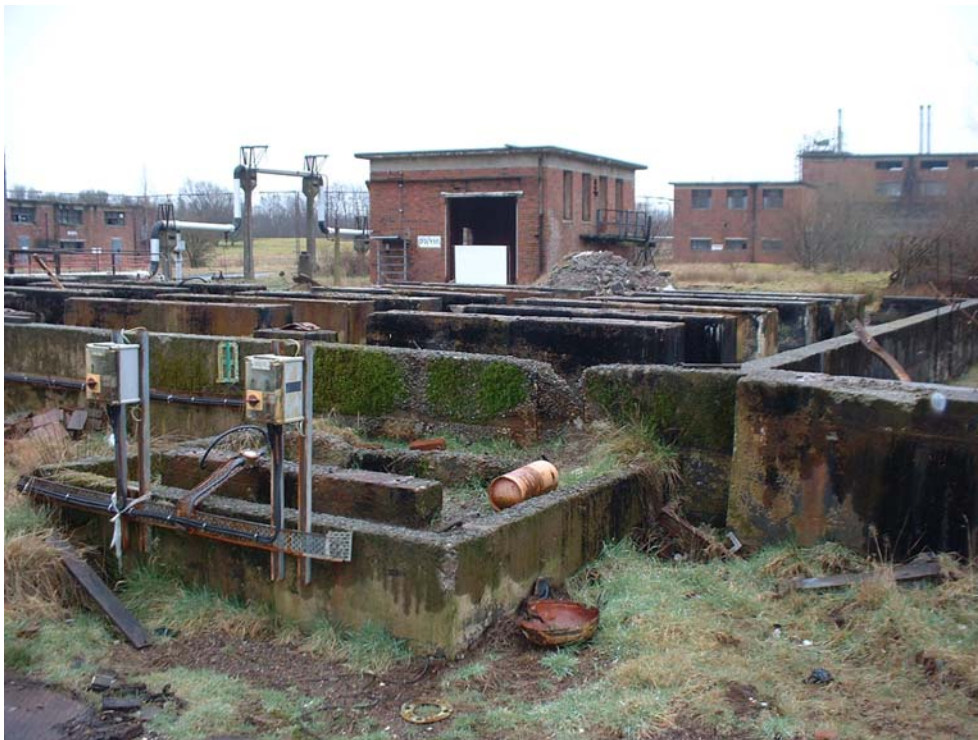
Plate 6.2 - Acid tank farm (22/102H). Concrete supports show signs of acid erosion.

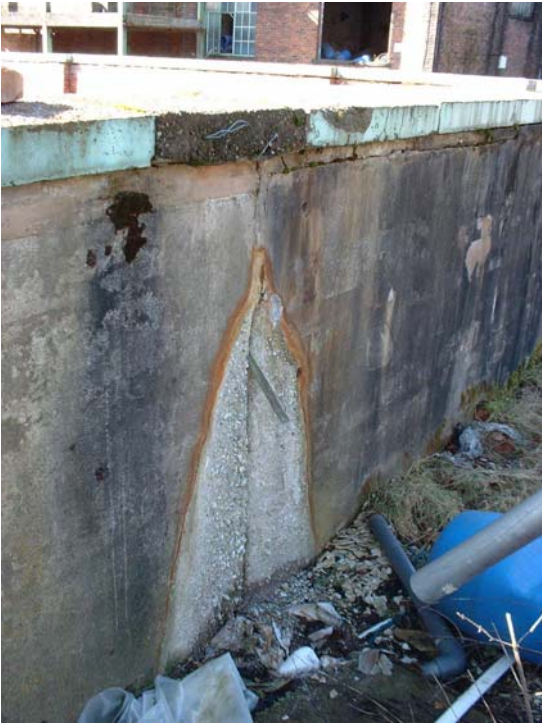
Plate 6.3 - Acid leakage from Spent Acid Storage Pond 34/274, Picrite Section.

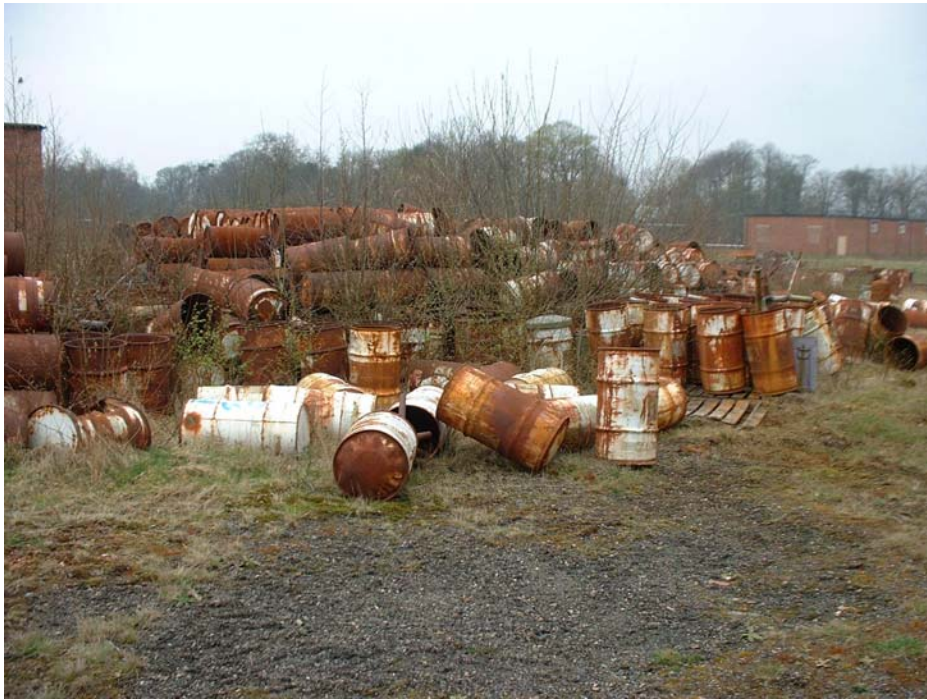
Plate 6.4 - Empty phosphorous drums to rear of 50/201, White Phosphorous Section
