Figure Title:  
**Figure 5 - Pictorial Representation of Remediation and Earthworks Activities**

Project:  
**Bishopton Stage I Investigation**

Project No: A385-00	Report No. A385-00-R6-1	Scale: NTS
------------------------	----------------------------	---------------

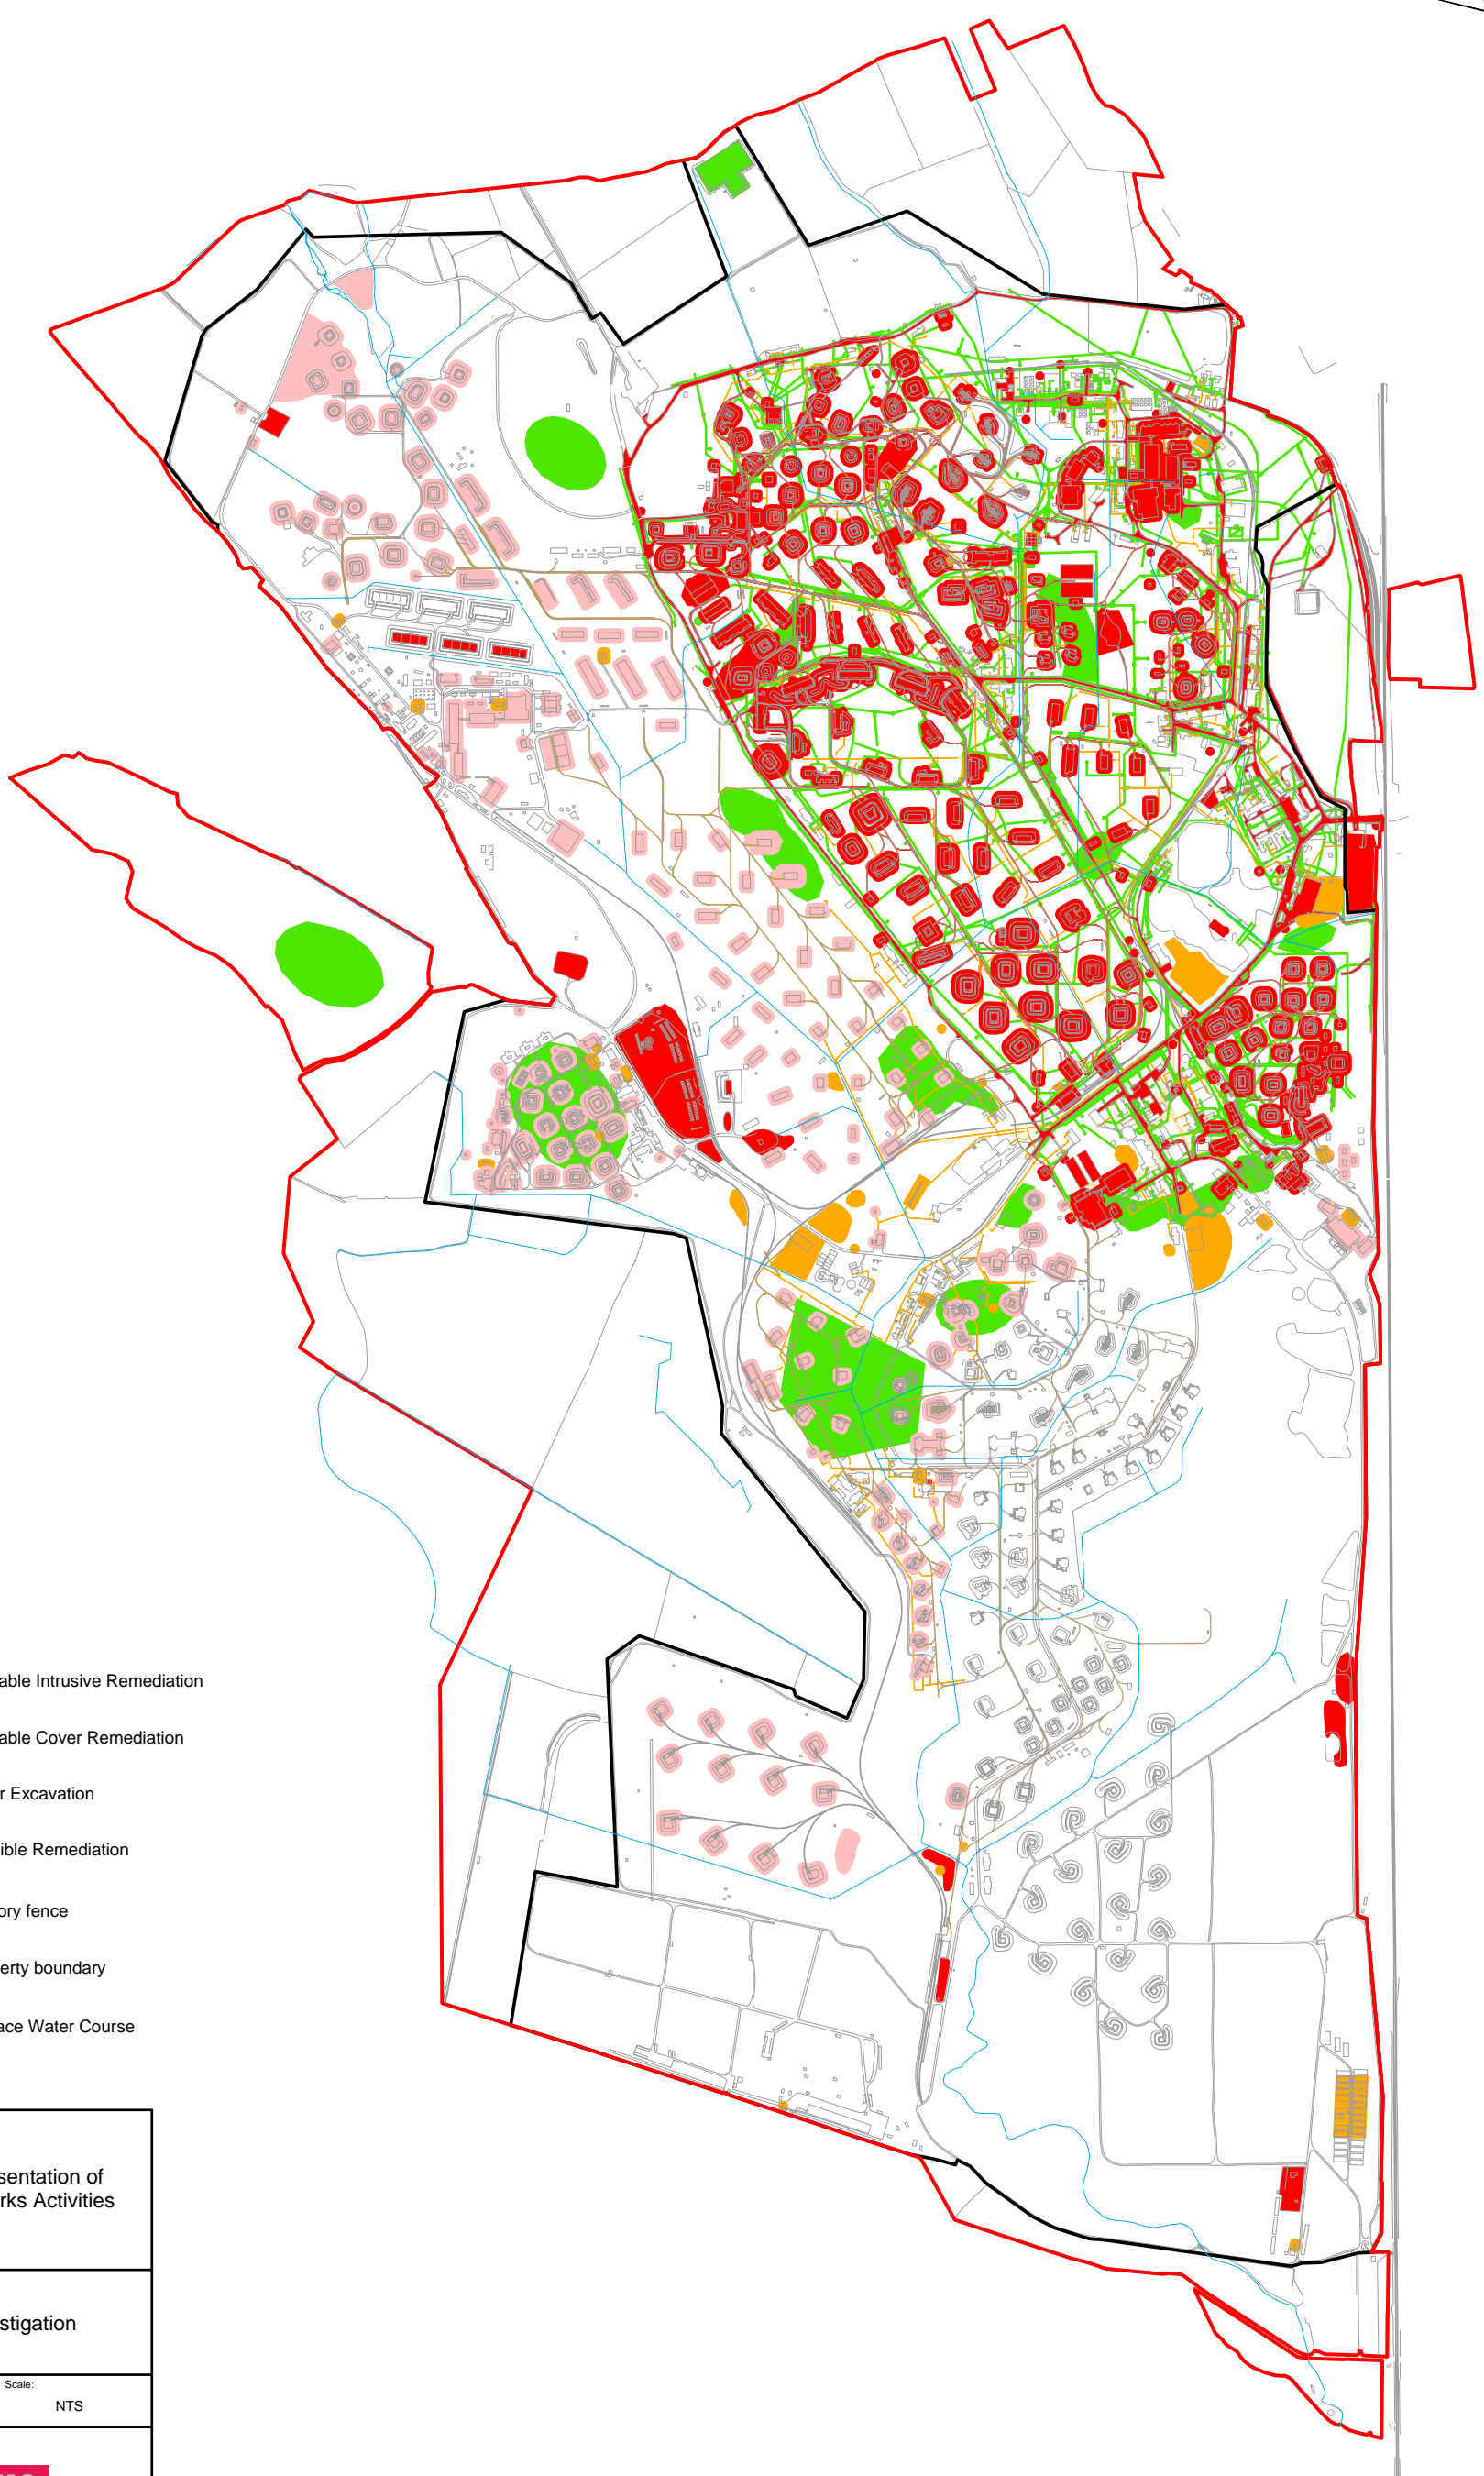
- Probable Intrusive Remediation
- Probable Cover Remediation
- Other Excavation
- Possible Remediation
- Factory fence
- Property boundary
- Surface Water Course
