Figure Title:
Figure 15 - Inspection of Narrow Gauge Track

Project:
Bishopton Stage I Investigation

Project No. A385-00 Report No. A385-00-R4-1 Scale: 1:7,500

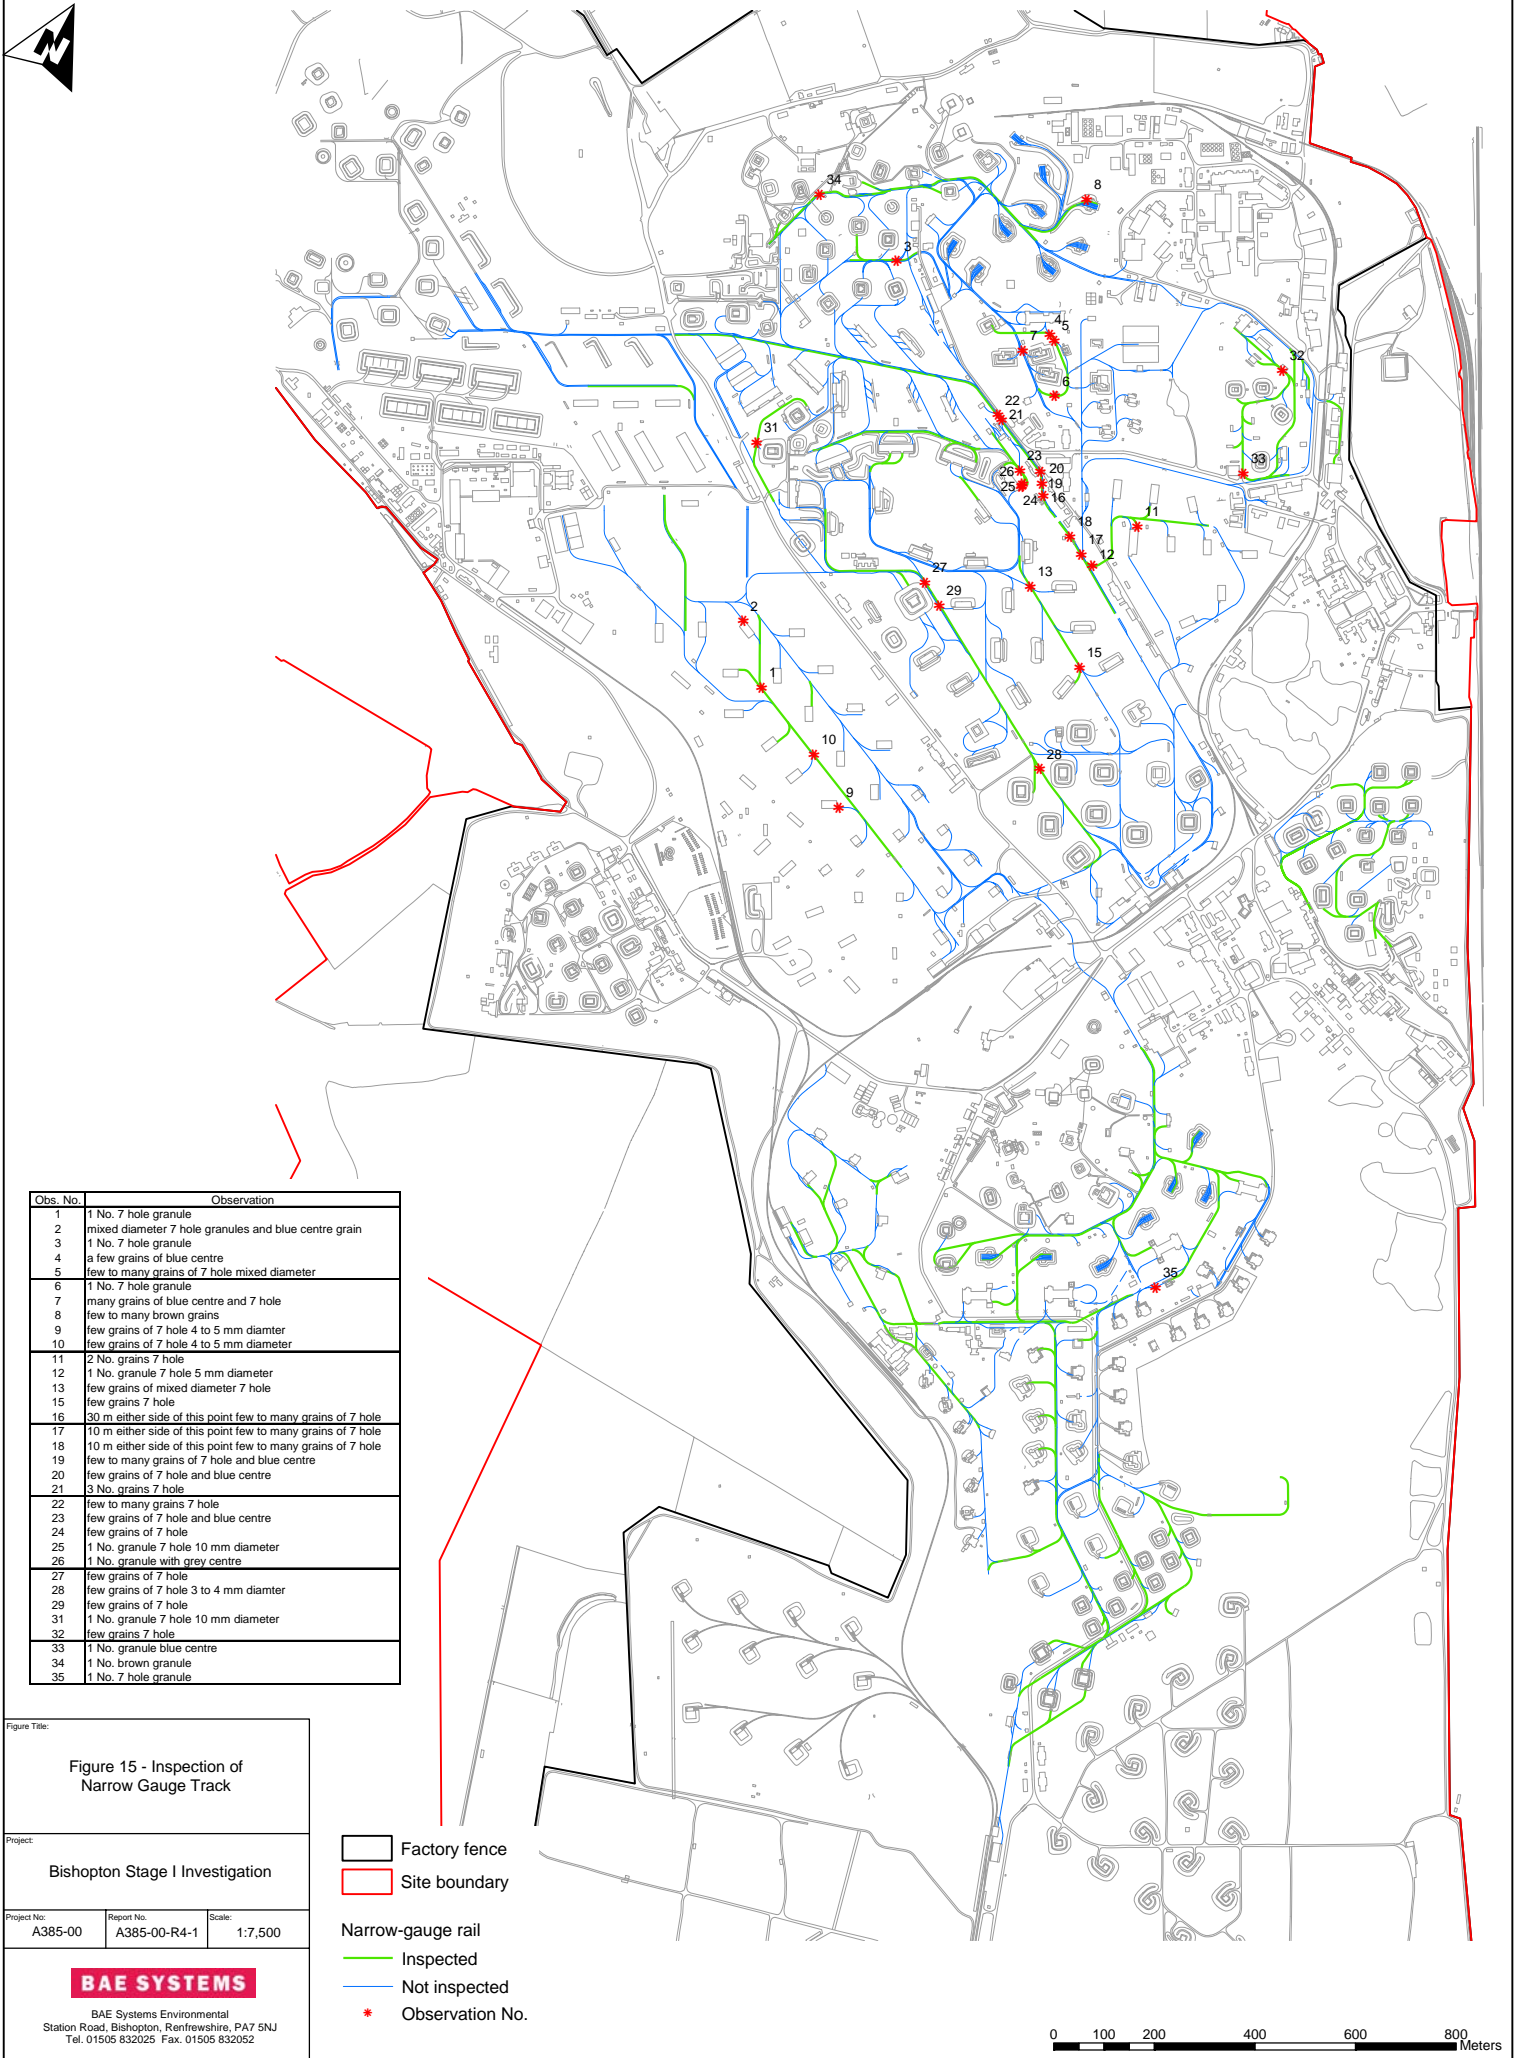
Obs. No.	Observation
1	1 No. 7 hole granule
2	mixed diameter 7 hole granules and blue centre grain
3	1 No. 7 hole granule
4	a few grains of blue centre
5	few to many grains of 7 hole mixed diameter
6	1 No. 7 hole granule
7	many grains of blue centre and 7 hole
8	few to many brown grains
9	few grains of 7 hole 4 to 5 mm diameter
10	few grains of 7 hole 4 to 5 mm diameter
11	2 No. grains 7 hole
12	1 No. granule 7 hole 5 mm diameter
13	few grains of mixed diameter 7 hole
15	few grains 7 hole
16	30 m either side of this point few to many grains of 7 hole
17	10 m either side of this point few to many grains of 7 hole
18	10 m either side of this point few to many grains of 7 hole
19	few to many grains of 7 hole and blue centre
20	few grains of 7 hole and blue centre
21	3 No. grains 7 hole
22	few to many grains 7 hole
23	few grains of 7 hole and blue centre
24	few grains of 7 hole
25	1 No. granule 7 hole 10 mm diameter

26	1 No. granule with grey centre
27	few grains of 7 hole
28	few grains of 7 hole 3 to 4 mm diameter
29	few grains of 7 hole
31	1 No. granule 7 hole 10 mm diameter
32	few grains 7 hole
33	1 No. granule blue centre
34	1 No. brown granule
35	1 No. 7 hole granule
